**REPORT NUMBER: RED-05-01**

**REPORT ON EARLY DISTRESS (RED)  
RETROFIT DOWEL BARS on I-39**

**FINAL REPORT**

**JANUARY 2002**

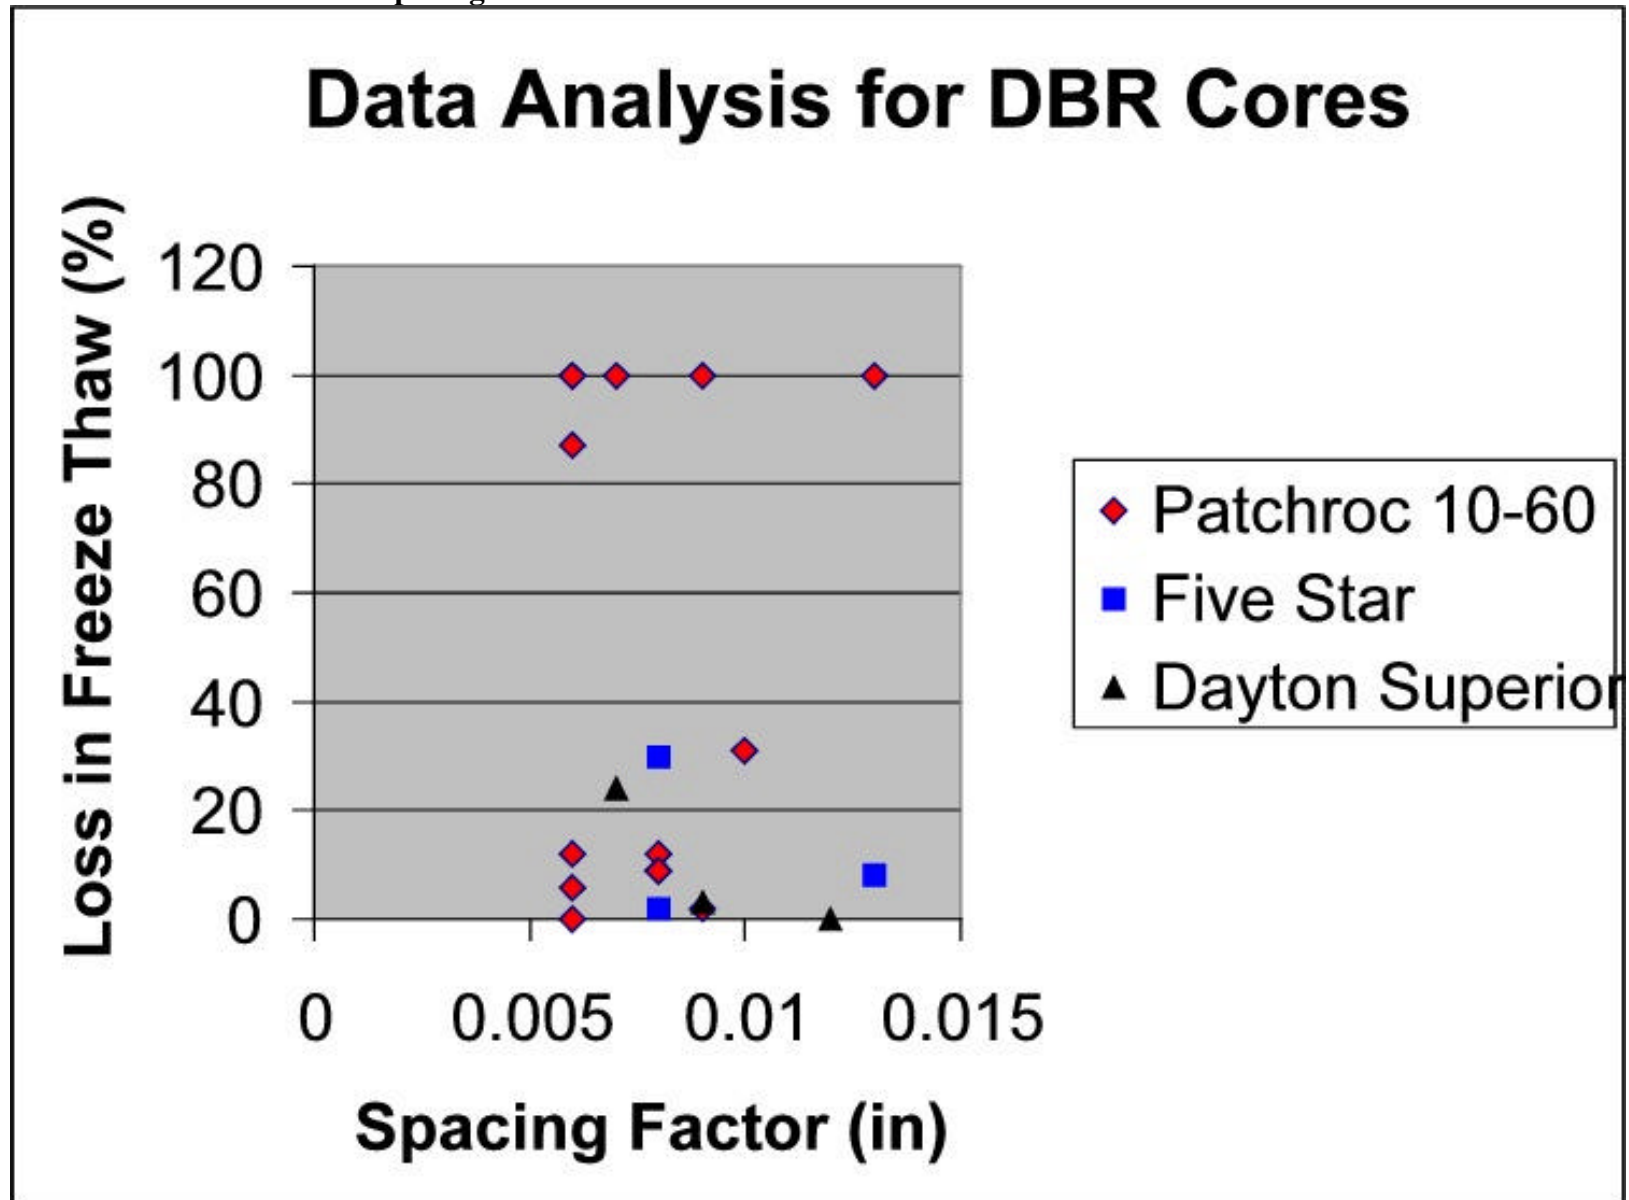
Figure 1 Freeze/Thaw vs. Air Spacing Factor

Freeze/thaw durability testing involves slicing the cores to extract the RDB slot mortar material and putting the samples in a freeze/thaw chamber and subjecting them to 300 freeze/thaw cycles, in accordance with Method A of ASTM C666. The relative success or failure of any given sample is measured by the percent weight loss after the test is completed. Five of the eleven cores taken from I-39 experienced 100% weight loss after 300 cycles in the freeze/thaw test. The six remaining samples not entirely destroyed after 300 cycles were kept in the freeze/thaw chamber for further testing in an effort to gather additional understanding of the mortar's long-term durability (See Table 2, page 29).

Freeze/thaw loss for the three core samples of Five Star Highway Patch from USH 18/151 ranged from 2% to 30%. Freeze/thaw loss for the three core samples of Dayton Superior (from USH 18/151) RDB Mortar ranged from 0% to 24%. It is interesting to note that the three core samples of ThoRoc 10-60C from the US 18/151 project showed significantly better results (2% - 9% loss) than the same mortar type used on I-39. As noted earlier, the ThoRoc 10-60C used on the US 18/151 project was placed @ 80% extension vs. 100% extension on the I-39 job. Table 2 in Appendix B (pg. 29) contains the freeze/thaw durability test results.

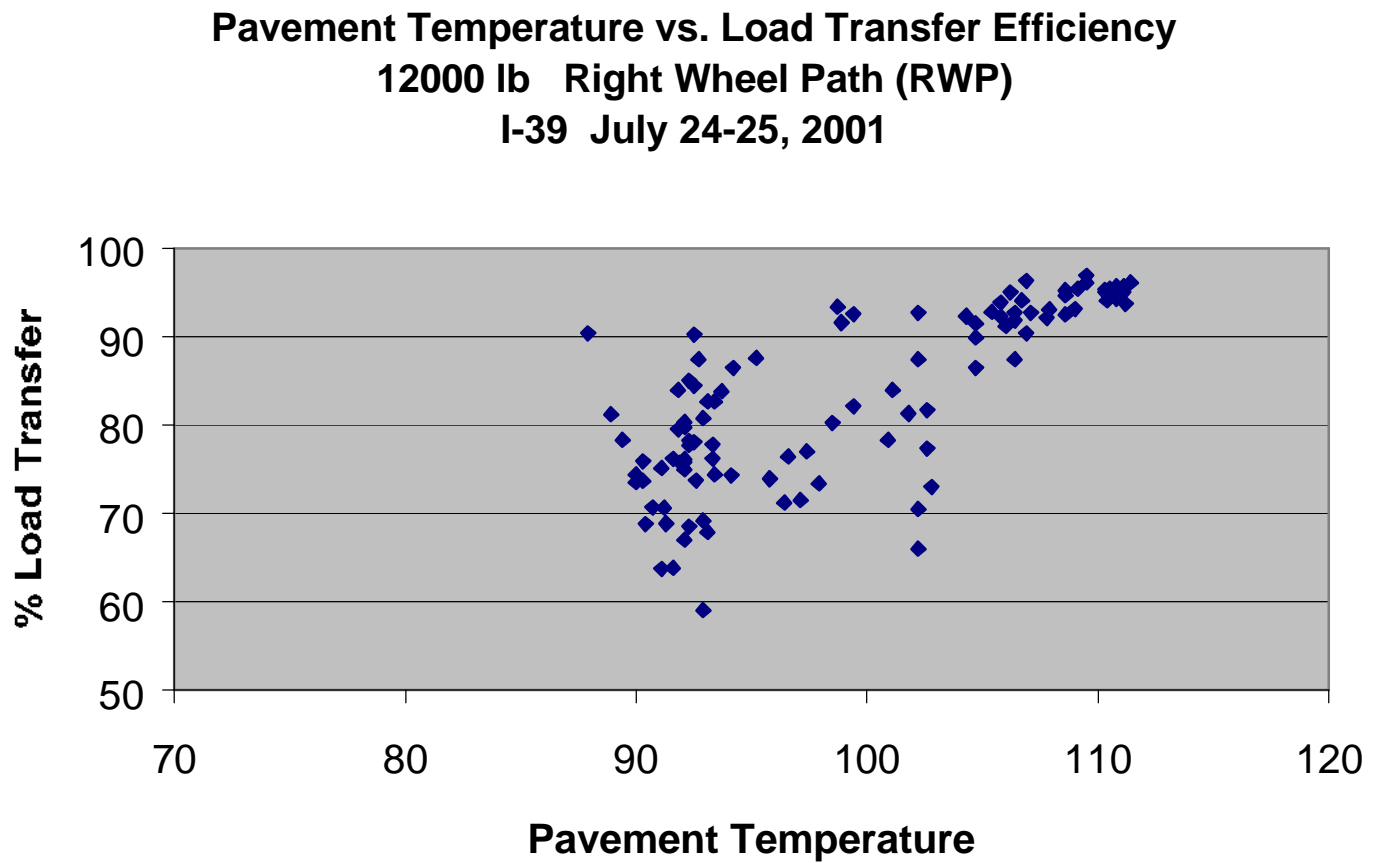
Figure 2 Pavement Temperature vs. Load Transfer Efficiency on I-39 (Follow-up FWD Tests)

As stated above, initial testing for I-39 was performed on March 1, 2001 with follow-up testing performed July 24-25, 2001. It is believed that during the March testing, the subbase was in a frozen condition resulting in higher load transfer results. Conditions for the first day of follow-up testing were sunny skies and ambient air temperatures of 83° - 97° F. with pavement temperatures in the range of 95° - 111° F. These conditions for the first day of follow-up testing also resulted in higher load transfer values due to expansion of the slabs and increased aggregate interlock. Conditions during the second day of follow-up testing were more conducive to obtaining reliable FWD test results. Skies were cloudy to mostly cloudy, joints were open and ambient air temperatures were in the range of 72° - 88° F. with pavement temperatures in the range of 88° - 101° F. Figure 2 in Appendix C (pg. 35) shows the relationship of load transfer efficiency vs. pavement temperature for the follow-up testing on I-39. As the pavement temperature increased, so did the resulting load transfer efficiency. FWD testing for US 18/151 was performed on March 8, 2001. No follow-up testing was performed on that project.

The test results for the follow-up testing in July of 2001 on I-39 showed that the average load transfer efficiency ranged from 0.71 to 0.95 for the right wheelpath in the doweled sections. The average values for the right wheelpath in the undoweled section ranged from 0.54 to 0.65. The average load transfer efficiency at the center of the joint between the wheelpaths ranged from 0.57 to 0.98 for the doweled sections and 0.42 to 0.47 for the undoweled section. The follow-up FWD test results can be found in Table 5 in Appendix C on page 34.
